F-111 Adhesive Bonded Repairs Assessment Program - Progress Report 2: Analysis of FM300-2K Repairs

Eudora S. Y. Yeo

Aerospace Division
Defence Science and Technology Organisation

DSTO-TR-3088

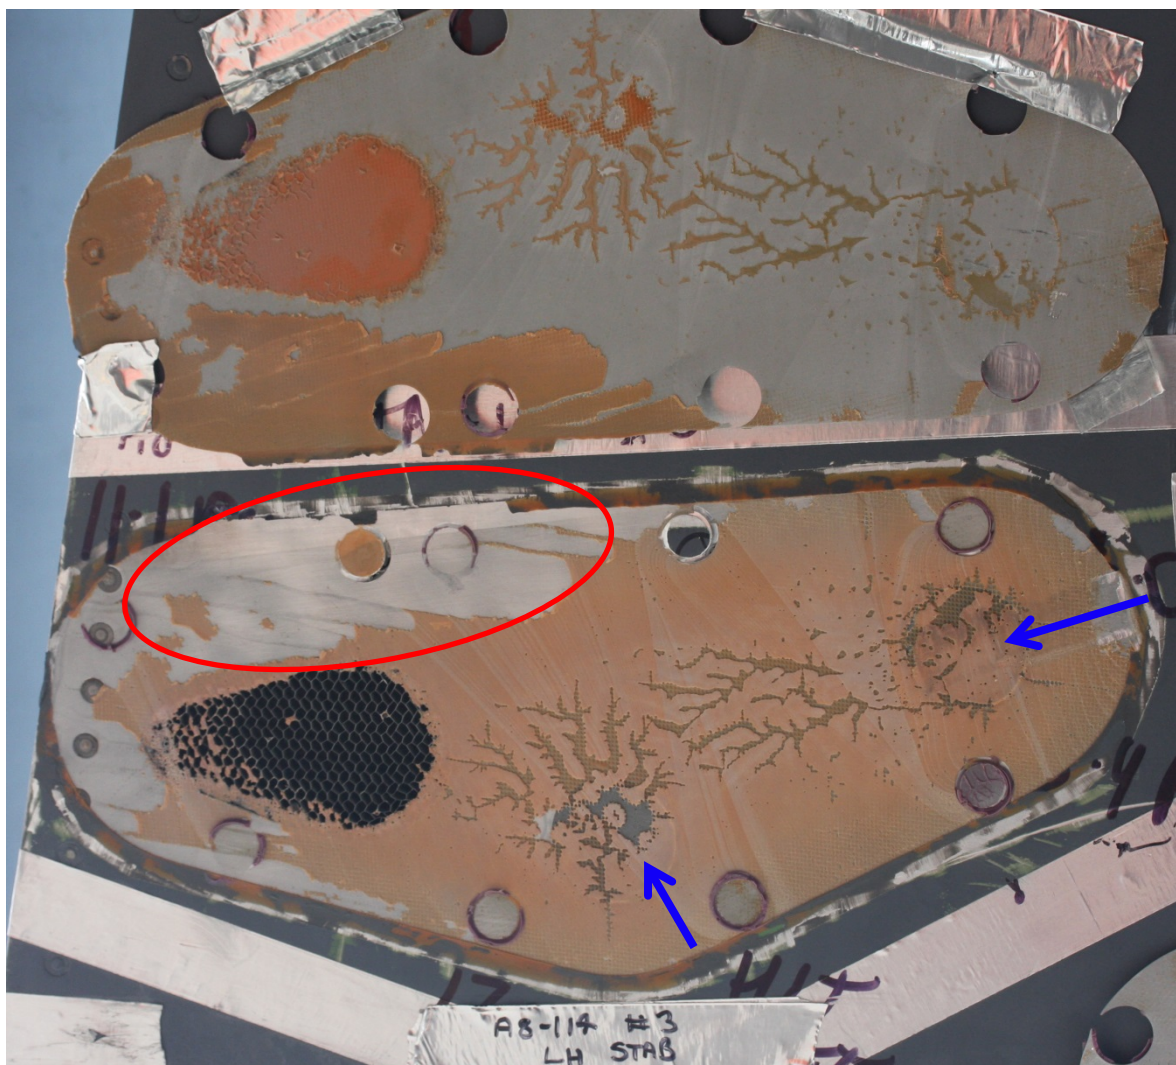
Figure 11 Repair 114-3 shows heavy voiding emanating from some of the areas of repaired core, indicated by the blue arrows. This is characteristic of inadequate drying following cleaning. The area along the top left of the repair, encircled in red, has an uneven appearance with shiny areas indicating insufficient gritblast.

Amongst the lowest strengths observed were stubs for which there were apparent adhesive wetting problems, highlighted in blue in Table 3. The example shown in Figure 11, in addition to heavy voiding, also appears to have had problems with wetting, most noticeably on the left side. Cases where the adhesive has not wetted either the doubler or aircraft skin are normally indicative of inadequate vacuum pressure being applied during the repair. It is more difficult to obtain good vacuum pressure close to the edge of a

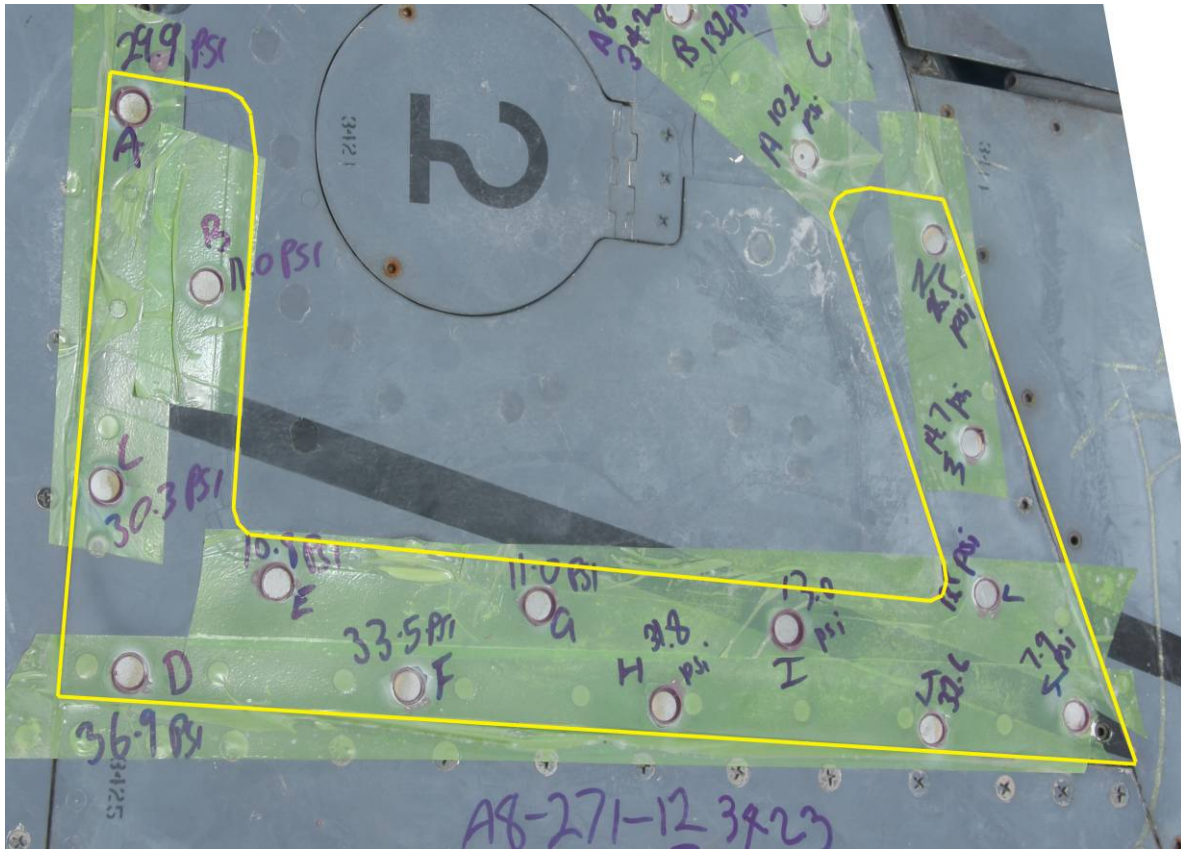
Figure 13 Repair 271-12, on aircraft A8-271, panel 3423

Repair number 271-12, made using FM300-2K, was chosen for closer inspection as a case study, as it had low and high strength stubs, and several stubs had a particularly unusual appearance. Figure 13 shows the repair, on panel 3423, outlined in yellow. Table 5 shows the strengths of the stubs on repair 271-12.

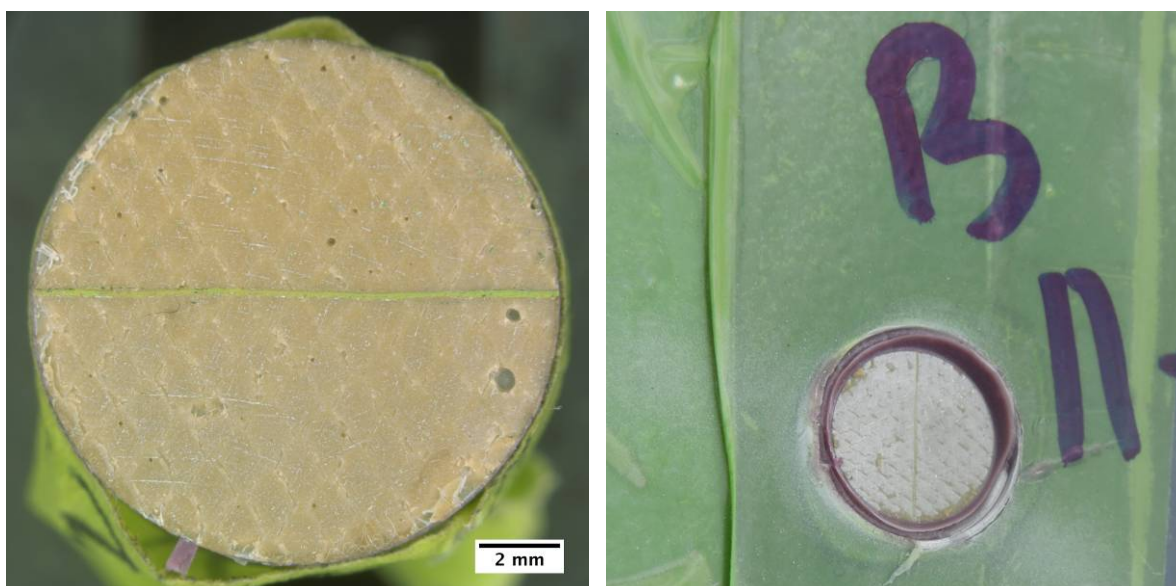
On closer examination of the failure surfaces, stubs B, E, G, I, L and N all appeared to have a line running across them. Figure 14a and Figure 14b show in greater detail the failure surfaces of 271-12B stub and aircraft side, respectively, which are typical of all of the abovementioned stubs. The line appears to be a greenish colour. High temperature “flashbreaker” tape is commonly used for many purposes in bonded repair operations, and one of these purposes is to mark out an area for cleaning. The green tape in Figure 13 and Figure 14b is the same high temperature tape – note that it is the same colour as the line across stub 271-12B, shown in Figure 14b. When the tape is removed from a surface a small amount of adhesive residue from the edge of the tape is sometimes left behind.

Figure 14 Failure surfaces were from low strength test stub 271-12B, showing the a) stub side, and b) aircraft side.

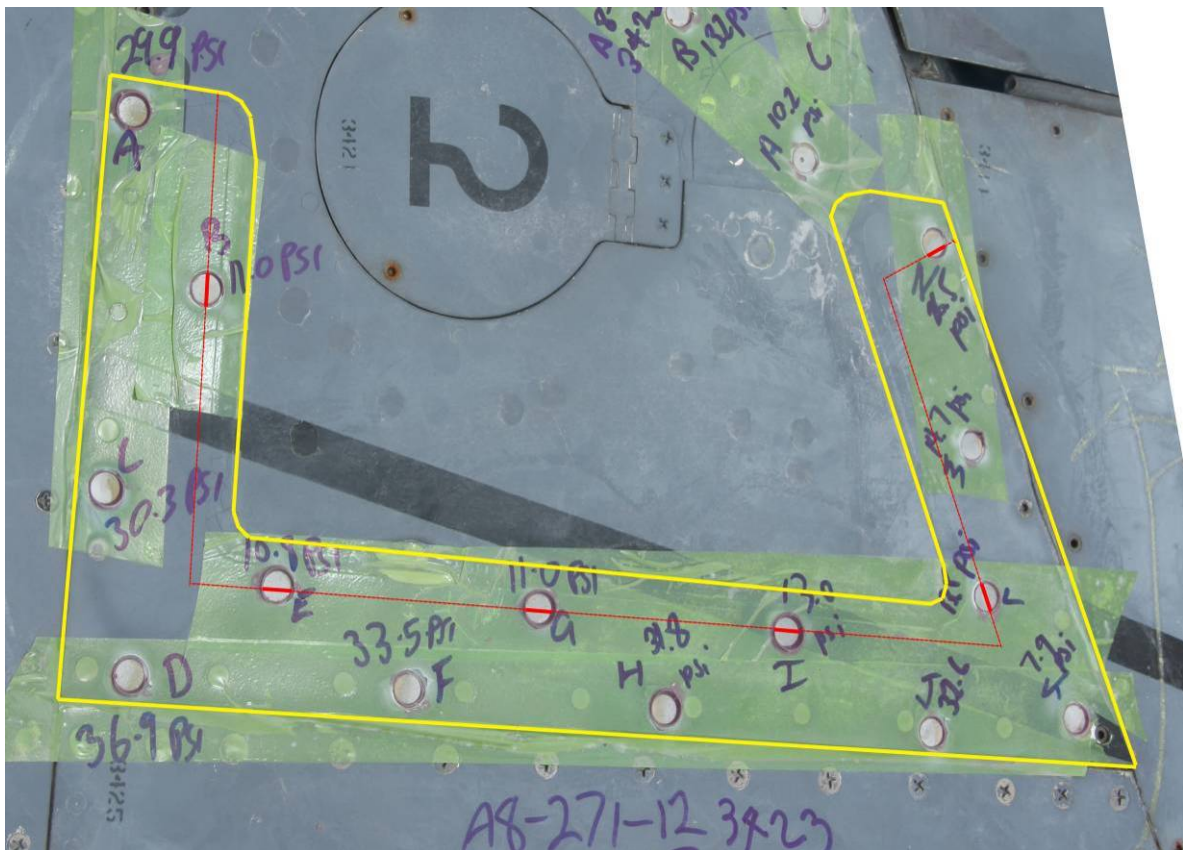
When all these green tape residue lines are marked out, as annotated in red on the photograph of the repair in Figure 15, it becomes apparent that the repair area had been marked out for cleaning, but that at some stage it was decided to enlarge the repair area. It appears that the additional repair area was not cleaned as thoroughly as necessary, as the green tape line should have been easily removed by wiping with a solvent-dampened tissue. If the enlarged repair area was not cleaned properly, it would explain why the above-mentioned stubs all had a lower measured strength than the other stubs on the same repair.

Figure 15 Repair 271-12, on aircraft A8-271, panel 3423, with tape residues annotated in red

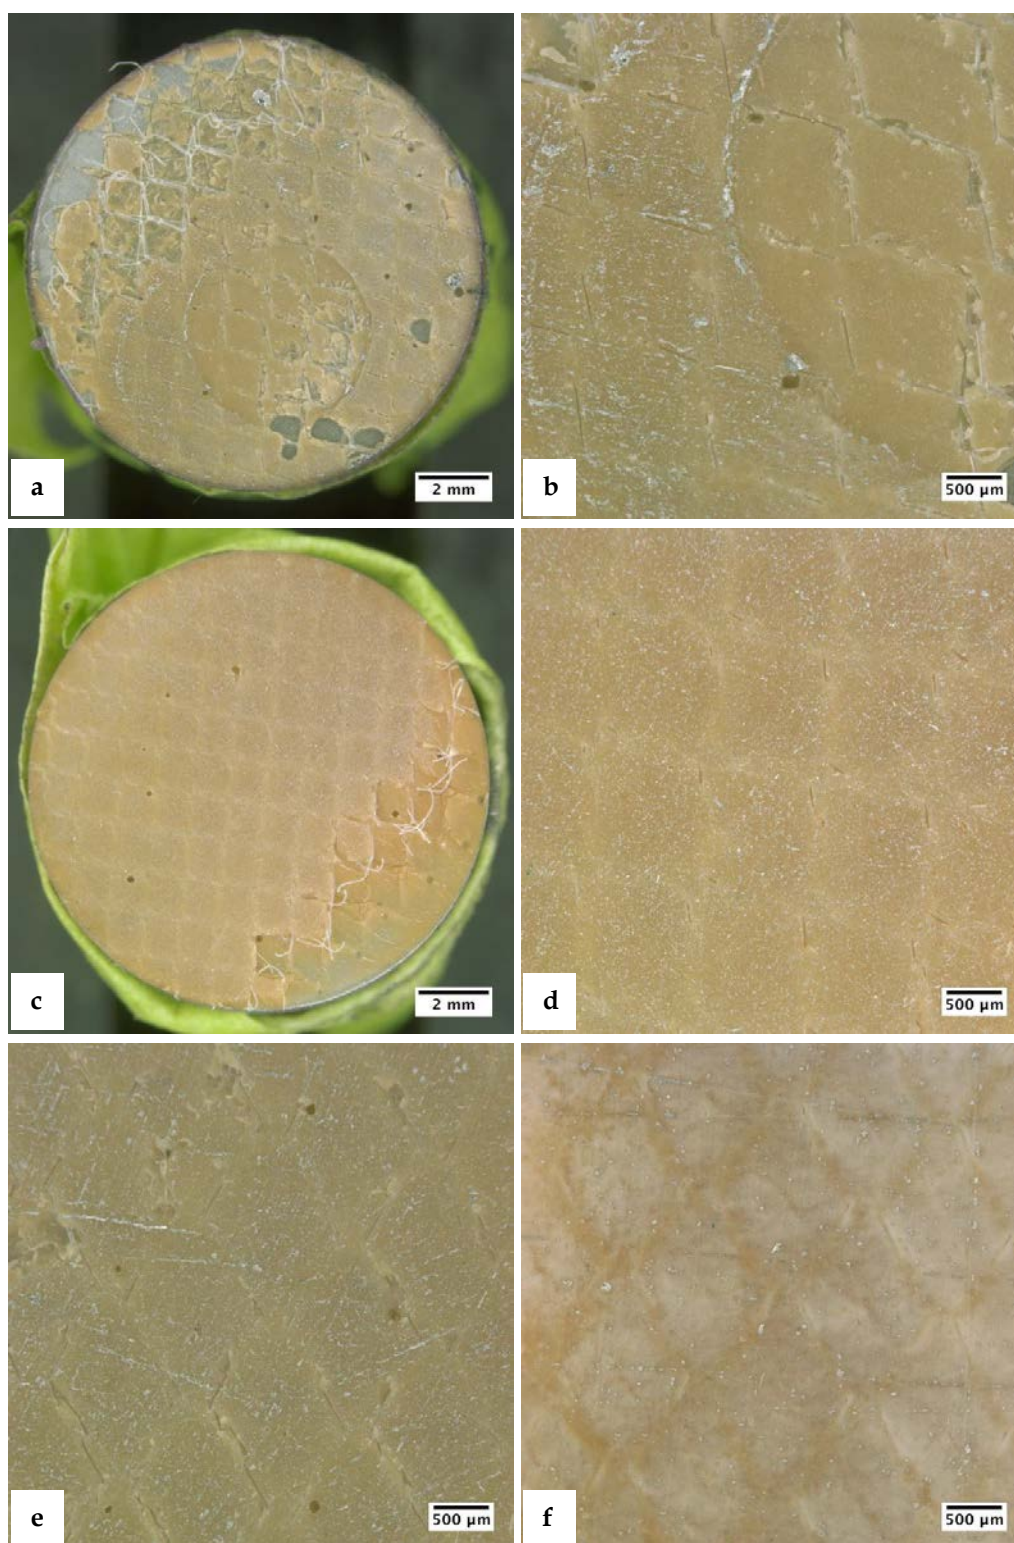
*Figure 16a) & b) Failure surface of stub 271-12J, which had high strength
c) & d) Failure surface of stub 140-07A, which had low strength
e) Failure surface of stub 271-12B, which had low strength
f) Failure surface of a requalification wedge test*

When stub 271-12B was examined in more detail (Figure 16e), it became evident that the metallic powder and lines are debris left over from the Scotchbrite abrasion step of the cleaning process. By comparison, stub 271-12J (Figure 16a and b) was a high strength stub, incidentally located over a rivet. The area bonded to the rivet head appears quite clean, with much less abrasion debris. The partial rings of debris on one side of the rivet suggest that the rivet was in place during cleaning, and the debris collected around the edge of the rivet. Later cleaning may have dislodged some of the debris, but did not completely remove it. The rivet may have had a higher hardness than the aircraft skin, which would make it more difficult to abrade, leaving less debris on the rivet head.

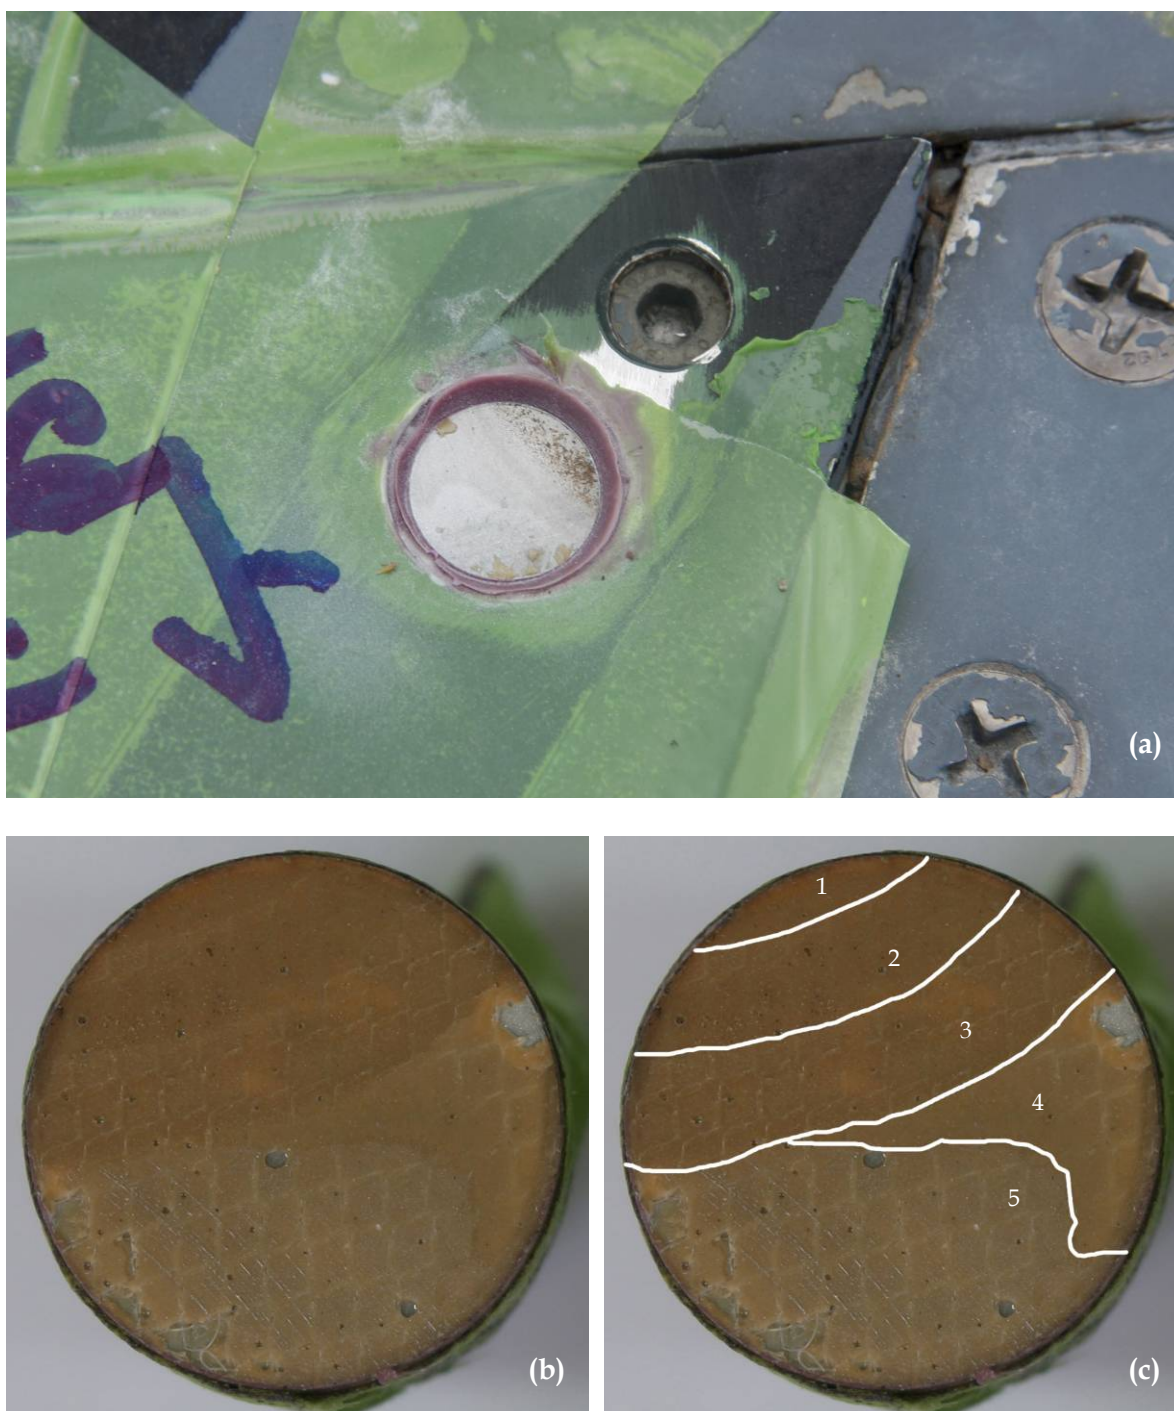
Another stub on repair 271-12K had one of the lowest strengths of all FM300-2K stubs inspected. This one was also examined more closely. Figure 17a and b show the aircraft side and stub side of the failure surfaces, respectively. Both sides appear to exhibit some contamination on parts of the failure surface. Focussing on the stub side, there is clear discolouration of the adhesive. The discolouration may have been caused by oxidation due to exposure to the atmosphere, or more likely, contact with fluid. The colour variation suggests that there were five distinct areas, corresponding to four different exposure events. These five areas are outlined for clarity in Figure 17c. It appears that a delamination may have begun in area 1, then progressed across areas 2, 3 and 4, before the stub finally failed in area 5 due to the PATTI inspection. The delamination may have originated from the fastener hole, and was probably caused and exacerbated by fastening/unfastening operations, however it is possible that there was some contamination of the surface in this area prior to bonding that may have contributed to low initial strength in the localised area, especially as fastener holes are likely to have grease contamination and are difficult to clean. It is unfortunate that the repair doubler was not removed, as the failure surfaces would have revealed more about the mode and cause of failure. Note that the delamination is over a very localised area and would have been discovered by non-destructive inspections before growing to a significant size.

Figure 17 The failure surfaces of test A8-271-12K, showing, (a) the aircraft side, (b) the stub side, and, (c) the stub side with apparent delamination progression zones marked.

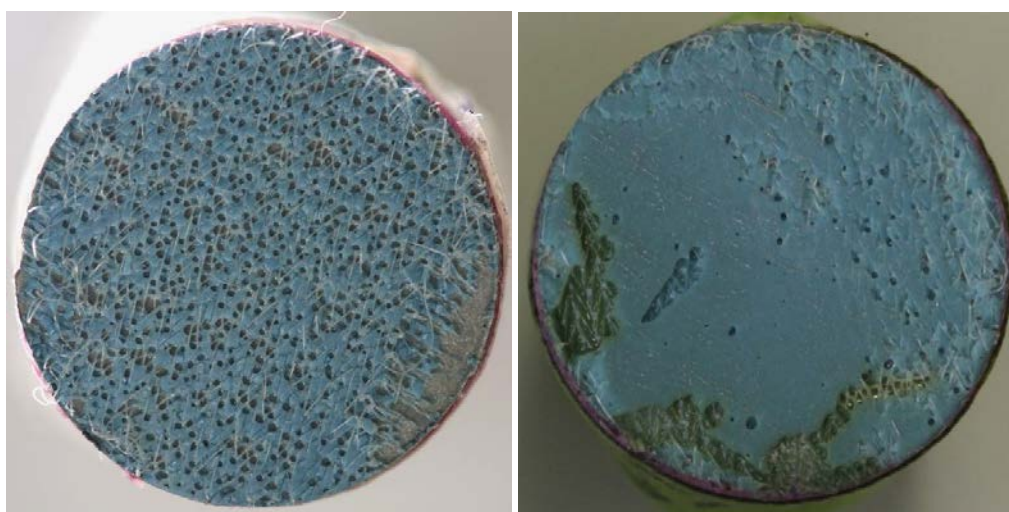
Figure 18 Test stubs A8-143-5J and A8-512-22A

It is also known that FM300-2K is supposed to be staged before use in vacuum-assisted repairs, i.e. the adhesive film is heated to remove volatiles such as solvents or water vapour before being used to bond a repair. However this requirement had not been captured in AAP7201.016-2, which outlines the procedures to be followed in preparation of a bonded repair, and it is known that adhesive staging is not currently being performed. Almost all on-aircraft repairs are cured under vacuum. Excessive volatiles on the bonding surfaces or in the adhesive during curing under vacuum will result in the volatiles being expanded by the vacuum. The FM300 failure surfaces almost all exhibited some level of voiding, but voiding is not so obvious in most of the FM300-2K failure surfaces. A typical FM300 failure surface is shown in Figure 18a, which contrasts with the FM300-2K failure surfaces shown in Figure 16 and Figure 17. Note that the majority of FM300-2K specimens failed at the adhesive/aluminium interface, whereas the FM300 specimens mostly failed cohesively (through the adhesive, away from the interface). Figure 18b shows one of the few FM300 failure surfaces that exhibited adhesion failure, and on closer inspection, silvery lines are visible (as discussed for FM300-2K in Figure 14), but not as easily noticed as the silver blends with the blue colour of the adhesive.
